SATELLITE 9443
DSCS II ANOMALY REPORT
NARROW COVERAGE DOWNLINK NOISE

14 AUGUST 1981

Report No. 36060-AR-024-01
CDRL No. 009A3
F04701-80-C-0022

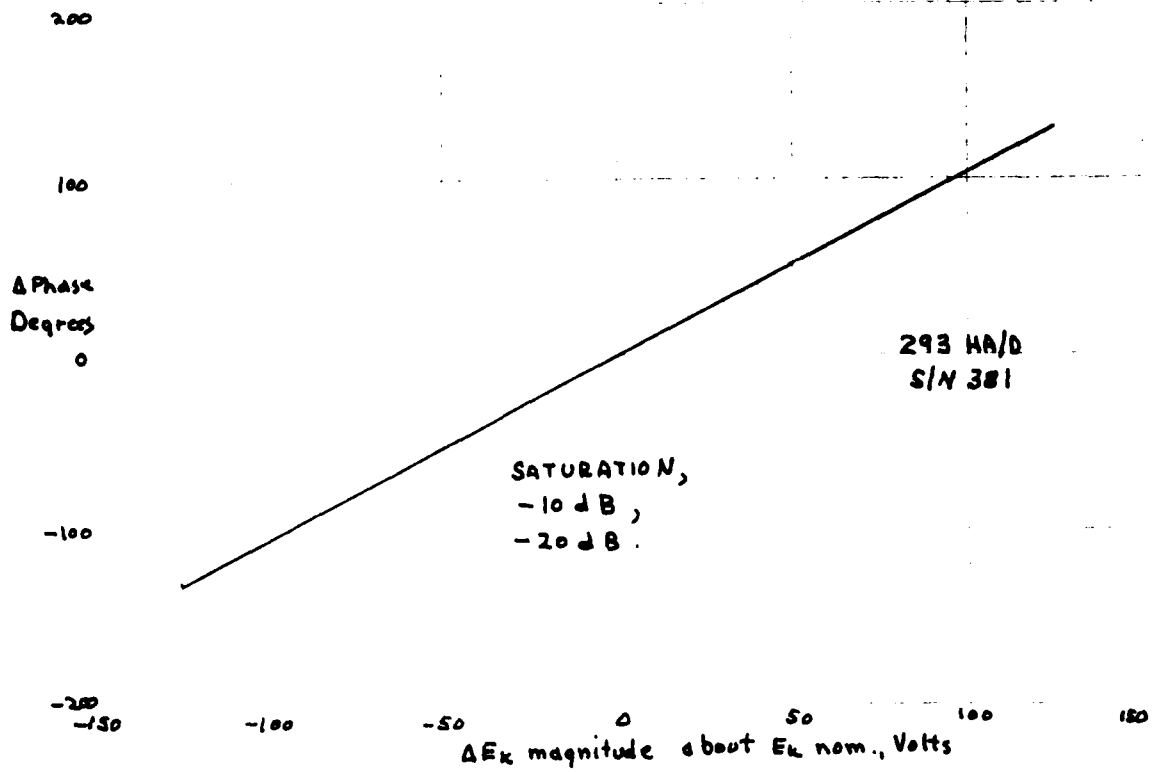
Figure 3.2.3.5-3. Variations in RF Output Phase For Two Drive Levels Vs Changes in Ek Magnitude

- (b) Phase Sensitivity. The sensitivity of RF phase to changes in cathode voltage is shown in Figure 3.2.3.5-3. Three sets of data were taken, including the conditions of RF saturation, 10 dB down from saturation, and 20 dB down from saturation. The three curves were identical within measurement tolerance and are shown as a single curve. The change in cathode voltage magnitude is plotted on the abscissa with the nominal value at zero. Increase in magnitude is to the right of zero. The slope of the curve is approximately 1.0 degree per volt for any excitation.

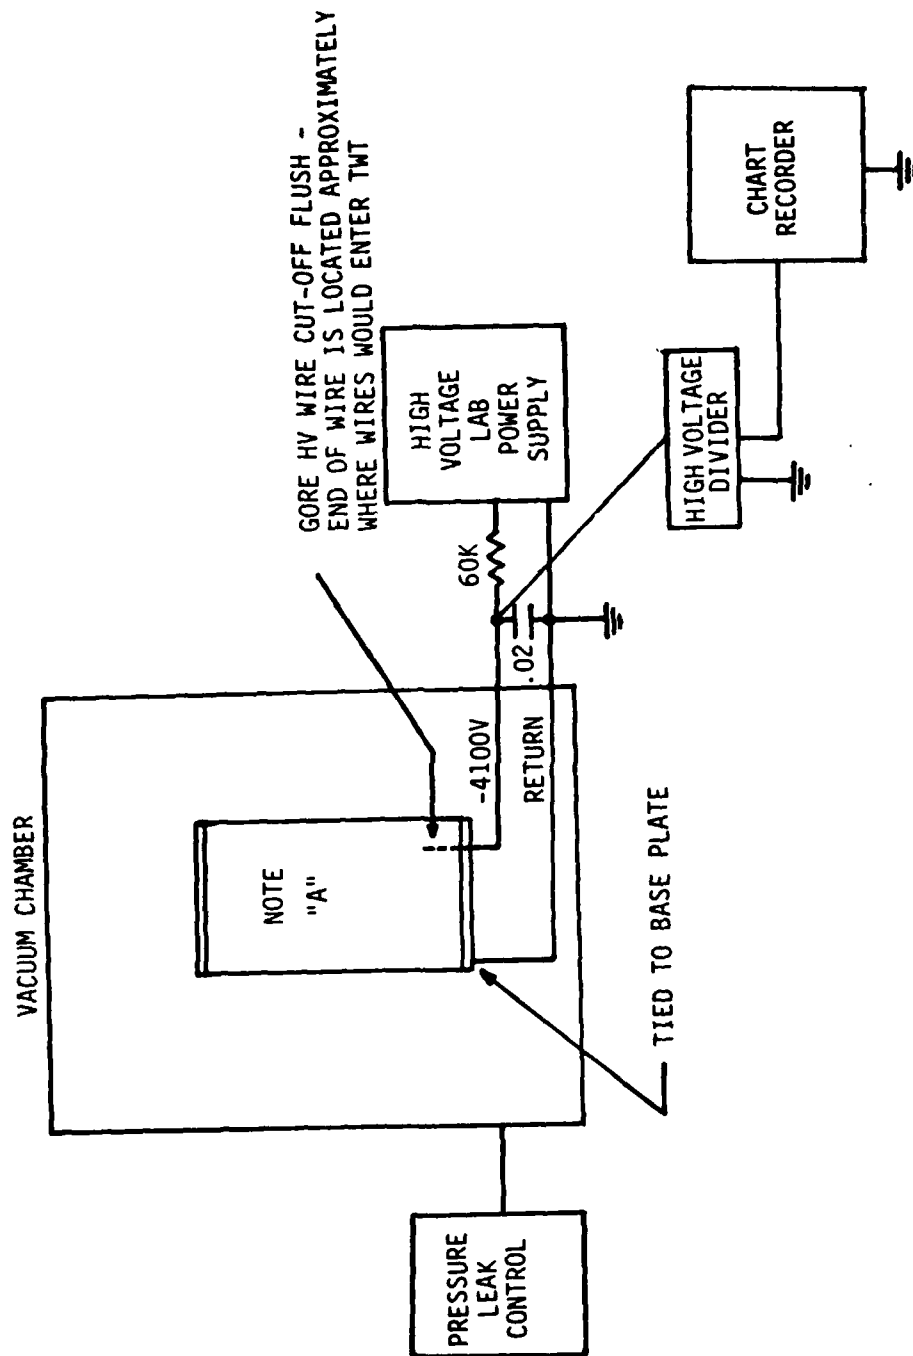
Figure 3.2.3.6-1. Configuration for Low Pressure Spark Tests

An experiment was designed to verify that relatively long sparks can occur at reduced pressure. A diagram of the apparatus used is shown in Figure 3.2.3.6-1. To simulate the condition within the 1241H EPC, a box was assembled consisting of a baseplate, end plate, center gusset, and cover from a 1241H EPC. A high voltage wire was placed within the box at a location approximately where the wire would enter the TWT in an actual TWT. This assembly was mounted in a vacuum chamber with the wire routed out of the chamber to a 4100 volt

NOTES: A. 40 Watt Baseplate, End Plate, Center Gusset and Cover

dc power supply as shown in the figure. The lead wire was monitored with a high voltage divider connected to a strip chart recorder.

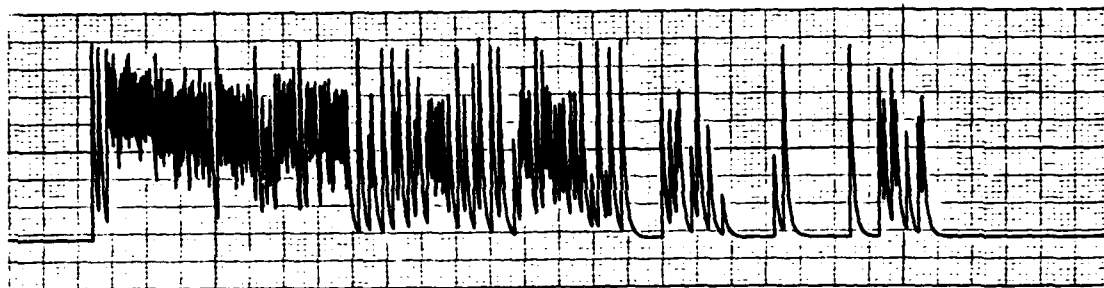
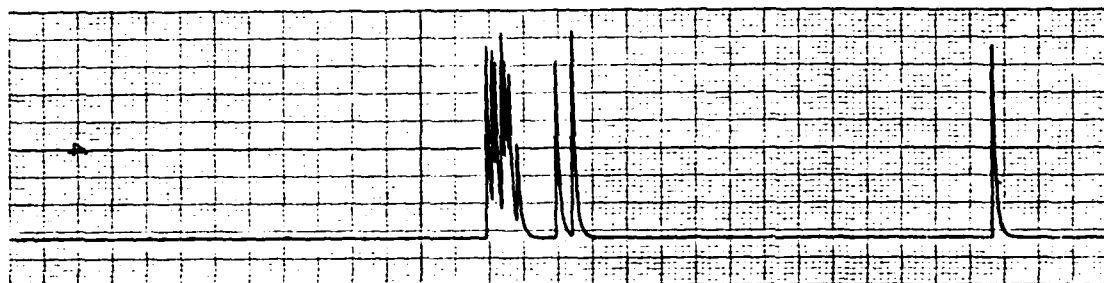
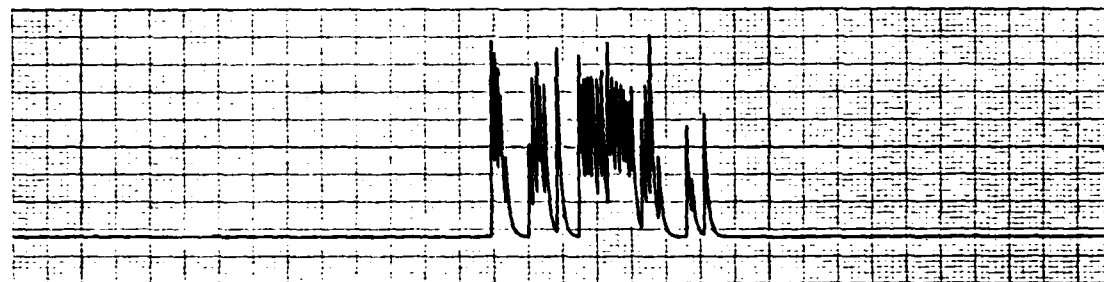
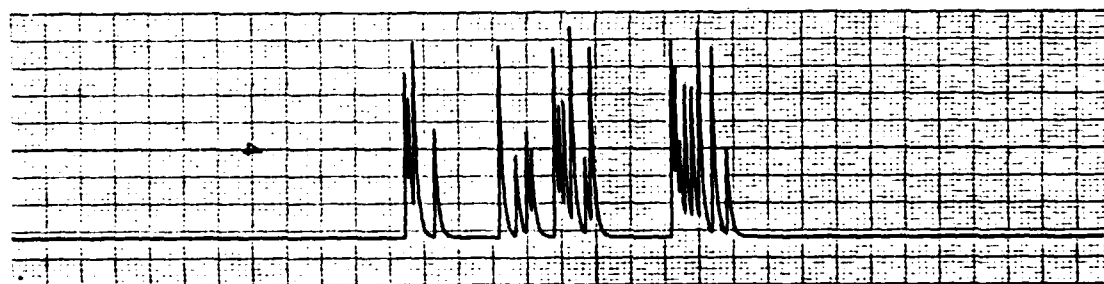
Figure 3.2.3.6-2. Spark Discharges at Reduced Pressure

The chamber was pumped to a high vacuum and the dc voltage was raised to -4100 volts. With the voltage applied to the wire, the chamber pressure was permitted to rise by using a controlled gas leak until a spark discharge occurred. The spark was observed visually and the character of the spark was recorded on the chart recorder. This experiment was repeated several times and the results shown in Figure 3.2.3.6-2. The pressure at which the spark occurred varied but was within the range of 0.01 to 0.5 mTorr. Spark lengths of the order of 200 mm were observed.

The character of the spark discharges was of interest. The discharge was not continuous but consisted rather of a series of discrete sparks in repetition. The mechanism appears to be an initiation at some voltage, the rapid reduction in voltage to where the spark extinguishes, voltage increase, then reignition. These spark trains were not continuous but did serve to show that under the right conditions of voltage and pressure, that a series of minor discharges can occur causing perturbation of the power supply voltage without initiating shutdown of the TWTAs.

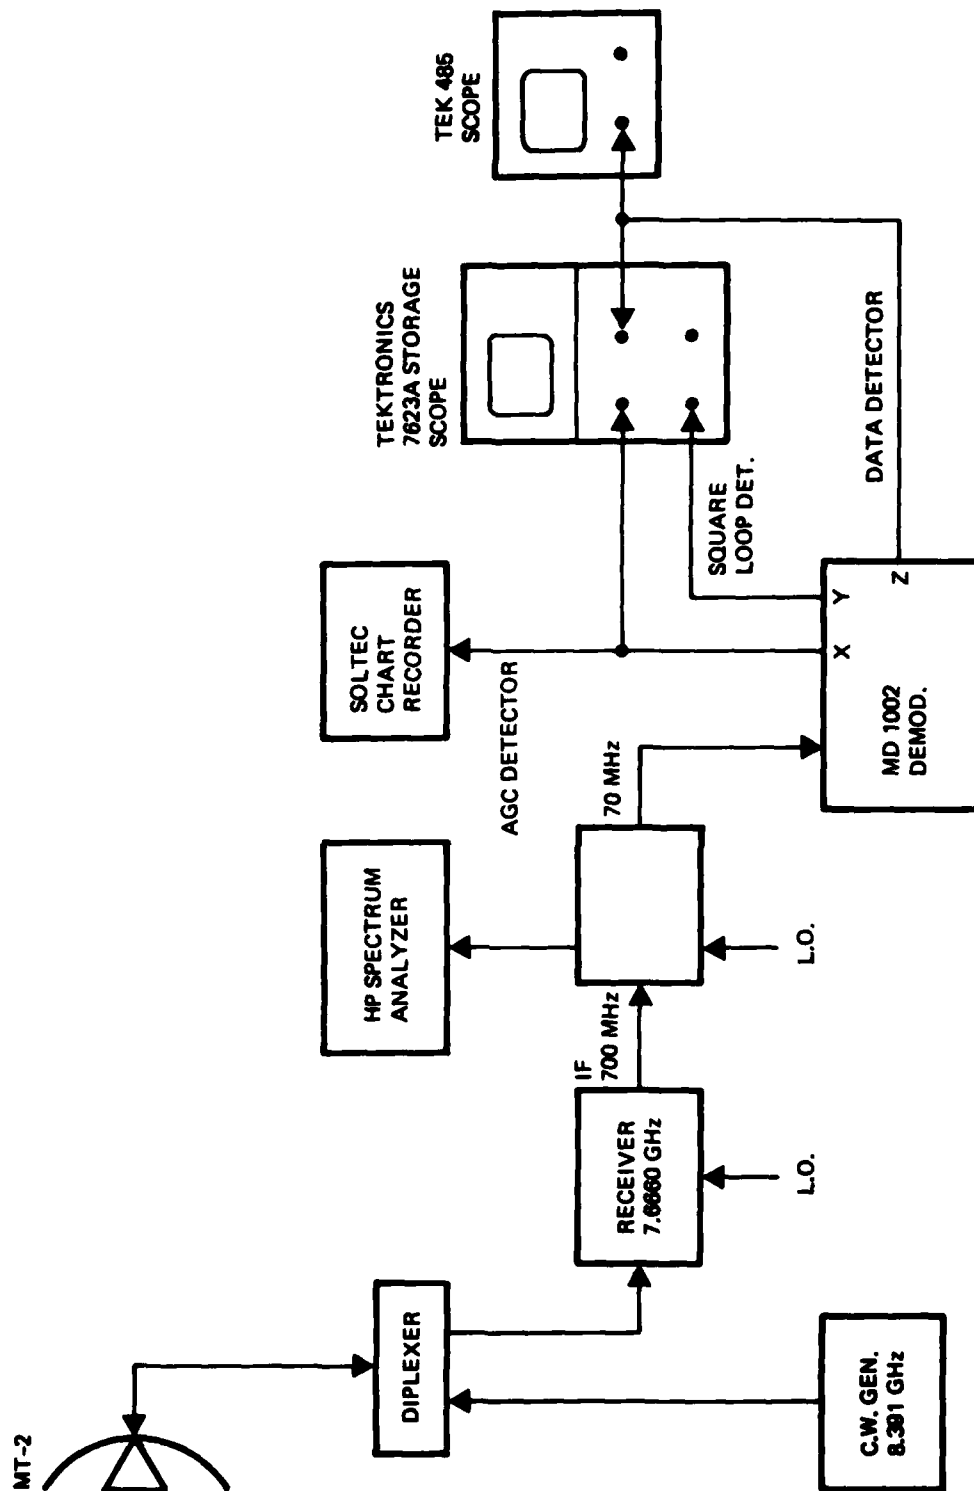
Figure 3.3-1. Harris Test Set-up

The test set-up to perform these tests is shown in Figure 3.3-1. On April 7, Harris began a series of tests by transmitting a CW signal and locking the MD1002 demodulator to the downlink carrier. Amplitude and phase variations were observed at the AGC power detector output and at the phase detector for the carrier phase-lock-loop (after the squaring process). These tests were continued a few hours per day over several days. Unfortunately, the number of spikes occurring at this time dropped off rapidly and good data was obtained only on the first day. On the latter days, few or no spikes were seen and no useful data was obtained.

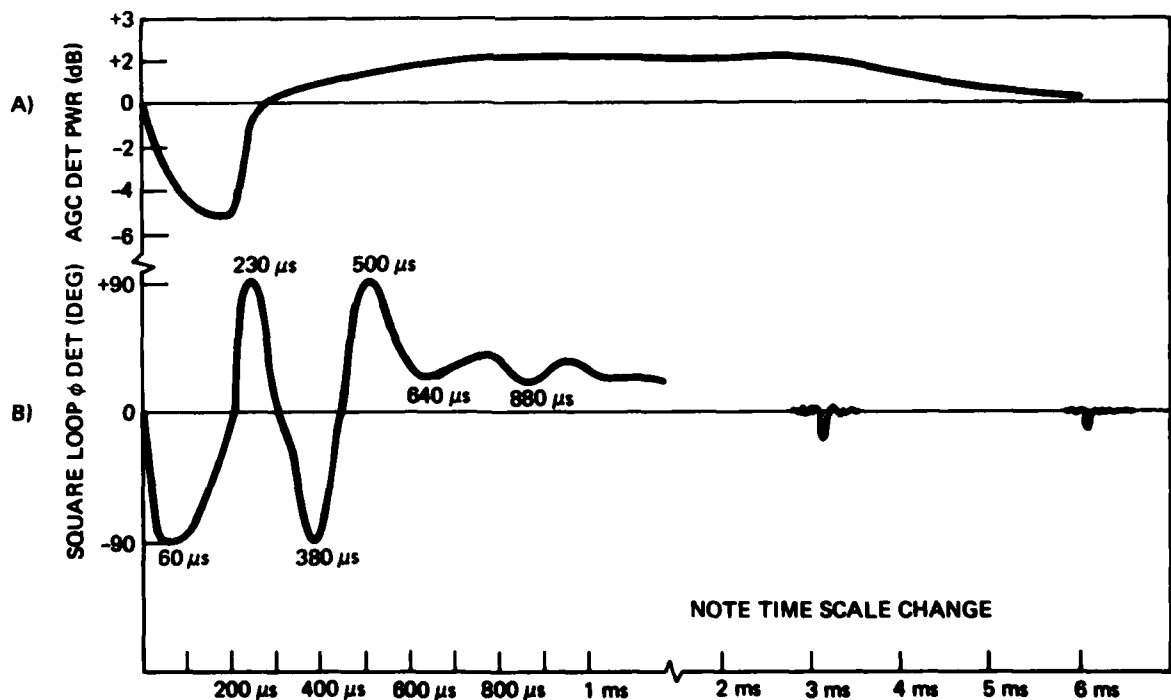
Figure 3.3-2. Harris Test Measurements

The amplitude and phase characteristics obtained from these tests are shown in Figure 3.3-2, plots (a) and (b). Since the carrier recovery phase-lock-loop phase detector was used, the data in (b) does not represent the phase shift directly.

However, since the phase detector output has the typical "S" curve characteristics, phase shift can be measured from (b), since one complete cycle at the phase detector output (with excursions through $\pm 90^\circ$) represents 360° of phase shift. From Figure (b), approximately 720° of phase shift has occurred during the initial 640 μsec . The actual phase shift would be half this value, since the recording includes the effects of the squaring process of the carrier recovery loop.

The 360° phase shift in the carrier is of particular significance since this is the cause of loss of signal lock and thereby, data. It was planned to modify a breadboard model of the demodulator to extend the tracking loop and determine if the system could operate satisfactorily in the presence of noise spikes. Unfortunately, before this test could be run, the noise spikes ceased (at least during the period of testing). Therefore, no conclusions could be reached on the usefulness of modifying the demodulator.
